# INDOOR AIR QUALITY ASSESSMENT

**Rehoboth Town Offices  
148 Peck Street  
Rehoboth, Massachusetts**

Prepared by:  
Massachusetts Department of Public Health  
Bureau of Environmental Health  
Indoor Air Quality Program  
August 2017

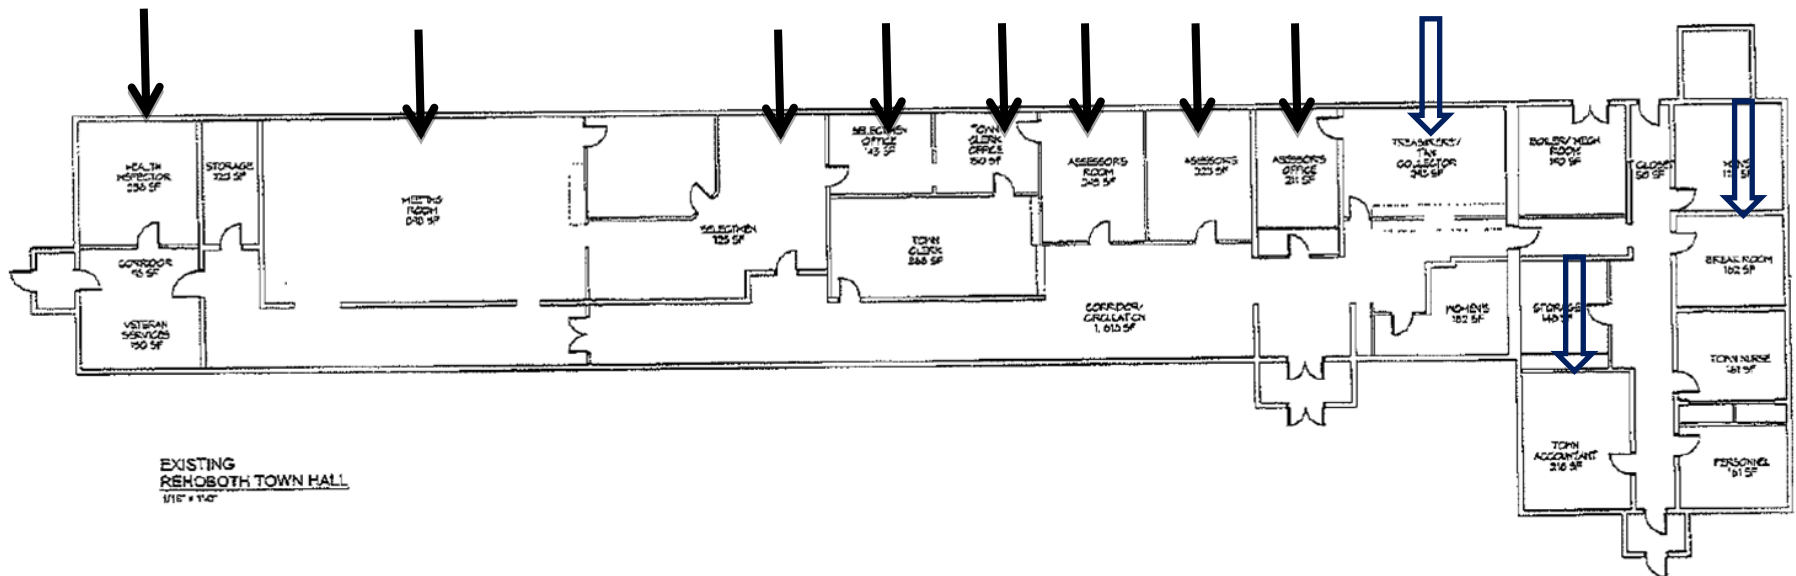
**Figure 1**  
**Rooms with Moistened Exterior Walls and/or Carpet**

In order to ascertain if wall materials were also moistened, moisture measurements were taken in wall materials. Measurements were taken in exterior walls around windows as well as interior walls for comparison (Table 2). Exterior walls in offices along the rear wall had significant moisture content (Figure 1). The source of moisture is likely water penetration from rainwater accumulation against the rear wall of the building. A deep soil trough exists along the rear wall (Picture 7), a likely result of water emptying from gutter/downspouts in the same location for over 50 years, which compressed the soil (Picture 8). During significant rainstorms, water accumulates against the building, which then penetrates along the slab/wall junction. This condition is exacerbated by the fact that the exterior wall and floor slab are buried. The exterior

Solid Arrow = moistened carpet and wall  
Open Arrow = moistened carpet only

3. Consider opening exterior walls in offices along the rear of the building to examine the wall material for dampness/mold growth. If mold colonized, consider replacing interior walls along the rear of the building with cement board.

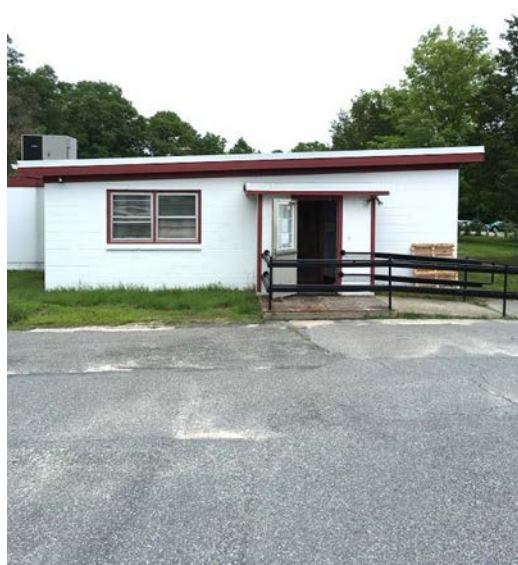
**Picture 1**

Moisture is penetrating into the vault due to several related conditions. The RTO was constructed with a sloped roof with gutter installed along the roof edge at the rear of the building (Pictures 1 and 2). In 1991, a vault was added to the rear of the building (Picture 3). The roof of the vault was made flat instead of with a slope matching the original roof. According to architect plans, the vault does not have a drain listed as part of the design. Water stains along the vault exterior walls indicate that rainwater pools on the roof and runs off the roof edges. Without adequate drainage, pooling water can damage the vault roof and create leaks inside the vault, particularly around ductwork. In addition, the floor of the vault has a number of cracks (Picture 4). If the cracks are completely through the cement slab, moisture from soil can easily migrate into the vault.

**Sloped roof**

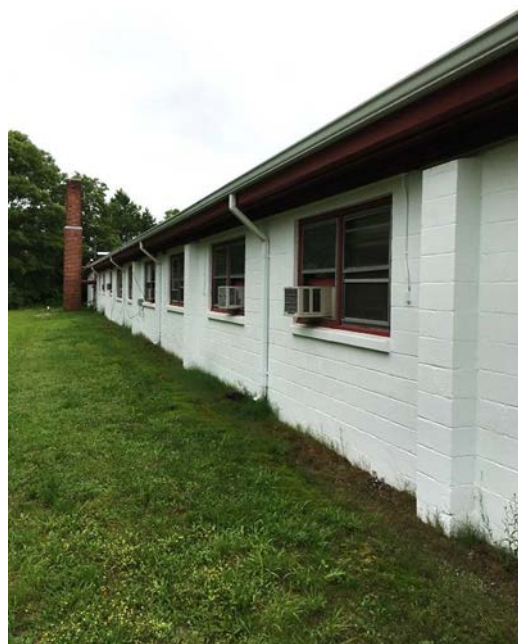
**Picture 2**

**Gutter on roof edge at rear of the building  
(Note slope of ground towards the base of exterior wall)**

5. Improve roof drainage. Install and maintain missing downspouts/gutters to collect and disperse storm water away from the building’s foundation. Extend downspouts to empty at least five feet from the building walls.

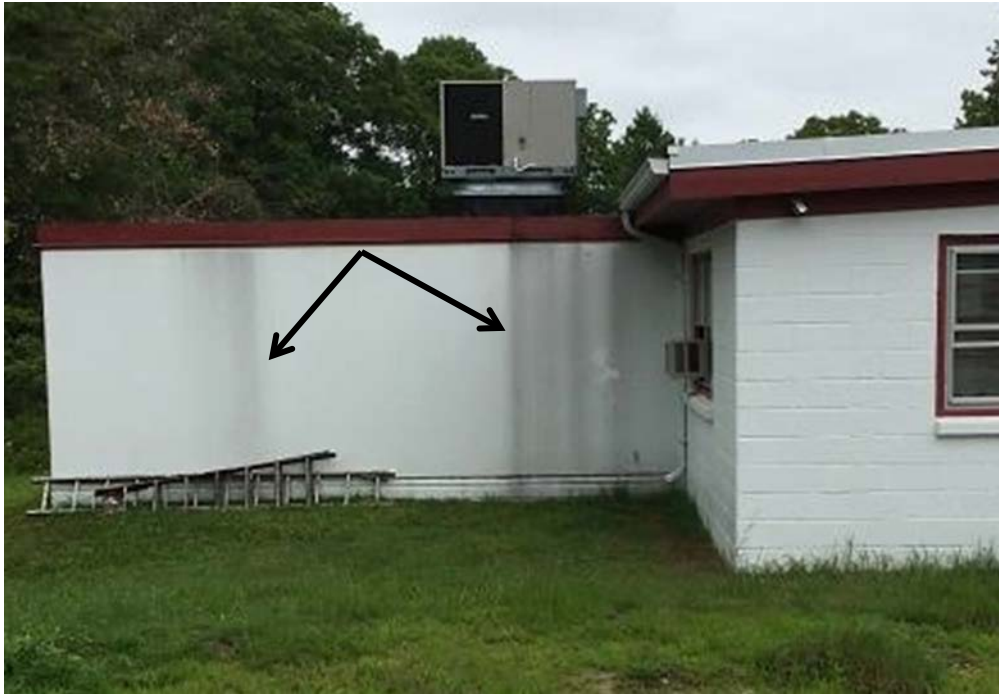
**Picture 3**

**The vault with flat roof [arrows showing heavy water runoff stains]**

6. Consideration should be given to installing a roof drain in the vault ceiling. This drain must have sufficient capacity to drain both the vault roof and the adjoining roof of the RTO. Installation of a drain would like require reroofing the vault to provide a proper pitch.

7. If installation of a roof drain is not feasible, installation of a roof component to redirect water away from the vault roof/HVAC system is recommended.

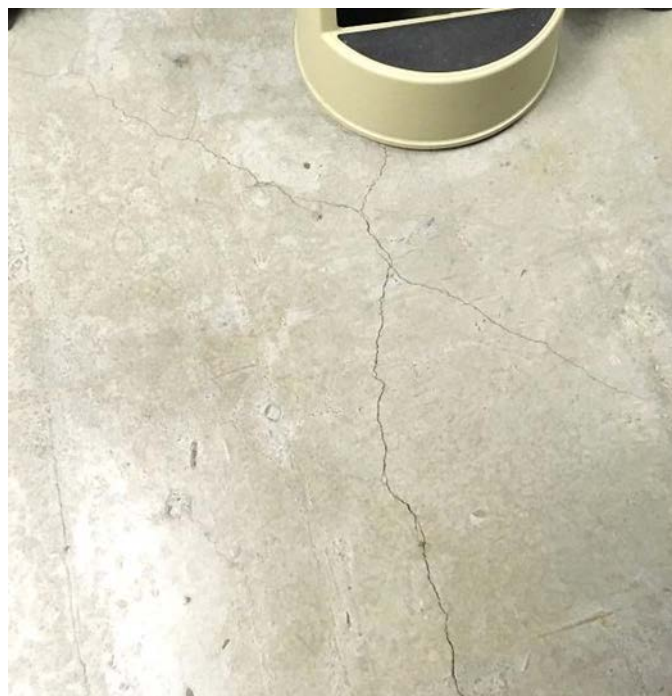
**Picture 4**

**Cracks in vault floor**

9. Seal the cracks in the vault floor.
10. Remove or trim back trees or shrubs within 5 feet of building exterior to decrease moisture against the building envelope.

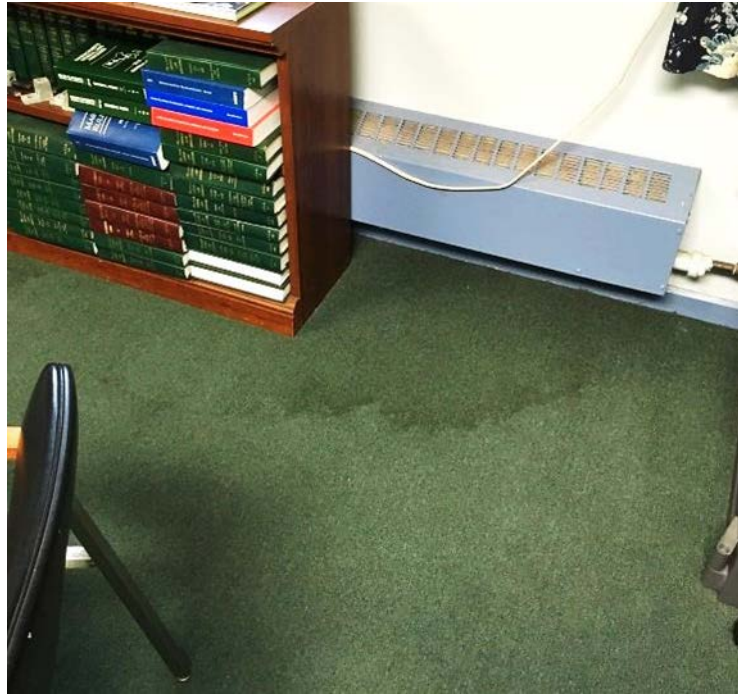
**Picture 5**

A number of areas have wall-to-wall carpeting that is water-stained (Picture 5). There are several possible sources wetting carpeting. Water staining appears to be along the exterior wall of each room, which can indicate water penetration through window AC installations. The spaces around ACs are not watertight and appear enclosed using particleboard. The particleboard appears to be heavily water-stained (Picture 6) and can support mold growth if moistened for longer than 24-48 hours. Under wind-driven rain conditions, water would readily enter around ACs. Another possible source is water penetrating through the exterior wall and/or floor slab. The cement slab of the RTO was likely not designed with either insulation or a vapor barrier. Without a vapor barrier or insulation, it is likely that the floor is prone to becoming moistened by condensation in hot, humid weather and/or water penetration through the slab.

**Water-damaged carpet**

1. Remove carpeting in a manner consistent with US EPA “Mold Remediation in Schools and Commercial Buildings” (US EPA, 2008). This work should be performed when the building is unoccupied. In addition, due to the age of the building and the presence of asbestos-containing floor tiles, all work should be done in accordance with state and federal regulations.

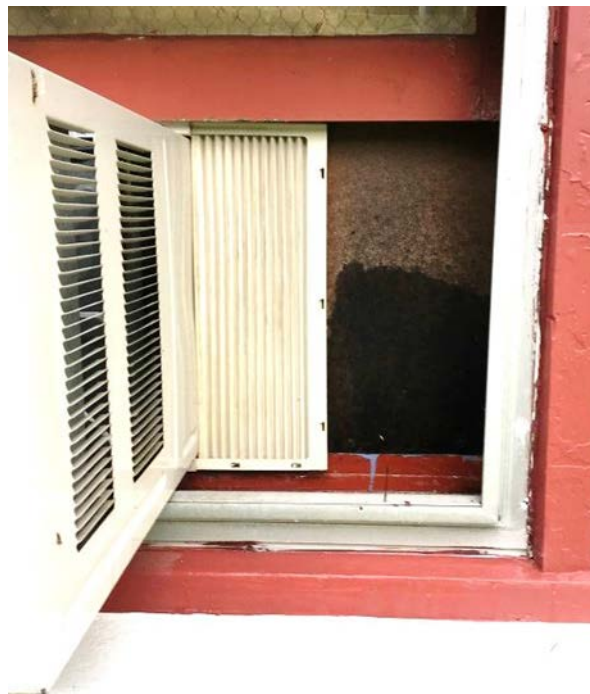
**Picture 6**

**Window mounted AC with water-stained particleboard**

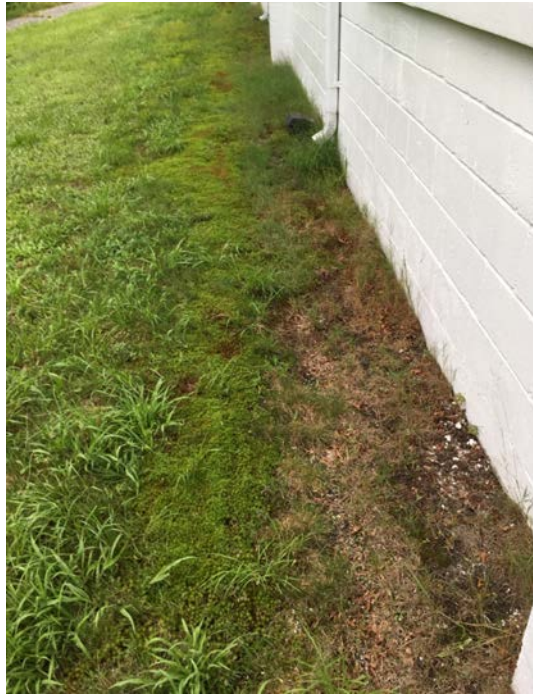
**Picture 7**

**Trough in soils against the rear wall**

8. Improve drainage from the rear of the building by re-grading the ground against the slab. If feasible, remove soil to a level low enough to unearth the exterior wall/floor slab junction.

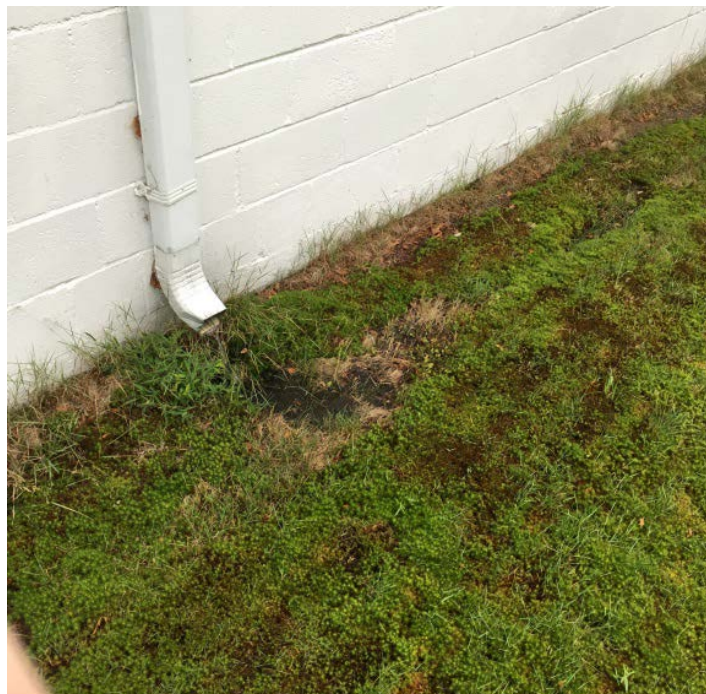
**Picture 8**

**Downspout emptying at the base of the wall; note scoured grass**

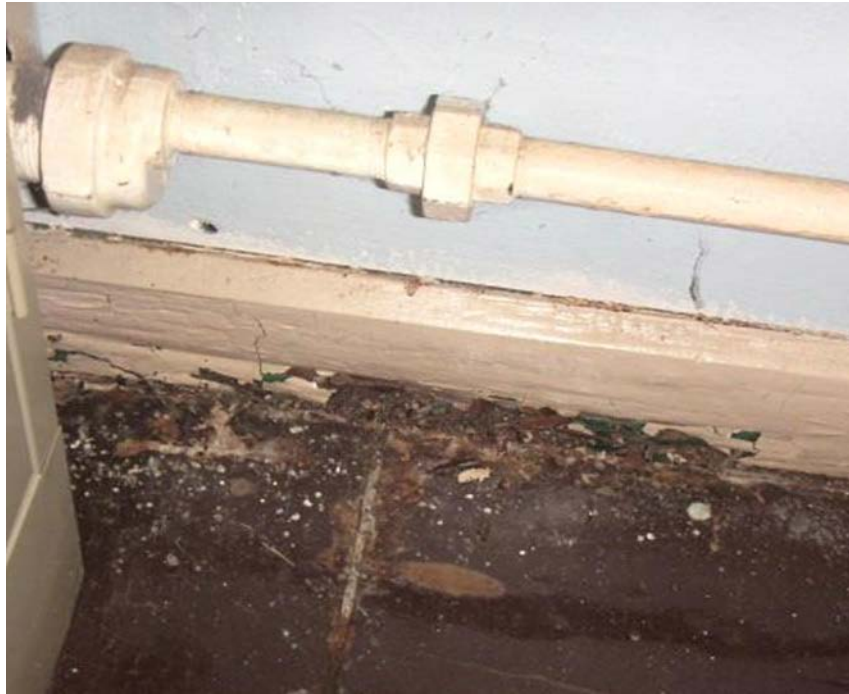
**Picture 9**

wall/floor junction should not be below soil, since water can penetrate into a building along the seam. This condition likely contributes to the rotted/damaged wood and sawdust/debris that was observed along the baseboard of the Selectmen's Meeting Room, which also shows signs of termite damage (Picture 9).

**Termite damage/rotted wood in Selectmen's Meeting Room**

22. Replace all missing covers for fluorescent light fixtures.
23. Contact a licensed pest exterminator treat/develop a plan for termite infestation.
24. Replace termite-damaged wood.

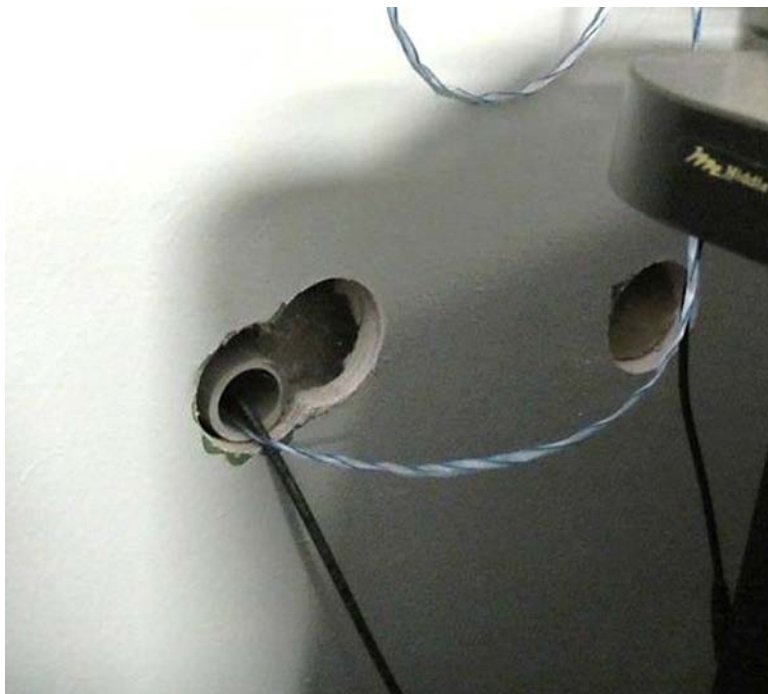
**Picture 10**

BEH/IAQ staff noted many holes/gaps in walls, ceilings, and floors (Pictures 10 and 11). These and any other gaps or breaches in the walls and ceilings should be properly sealed to avoid the migration of particulate matter, odors, moisture and pests into occupied areas. In the kitchen area a ceiling tile was ajar, exposing fiberglass insulation (Picture 12), which can be a source of eye, skin and respiratory irritation.

**Open utility holes in wall**

12. Refrain from storing porous items (e.g., paper, cardboard) in areas prone to chronic moisture.
13. Seal open utility holes with a fire-rated sealant.

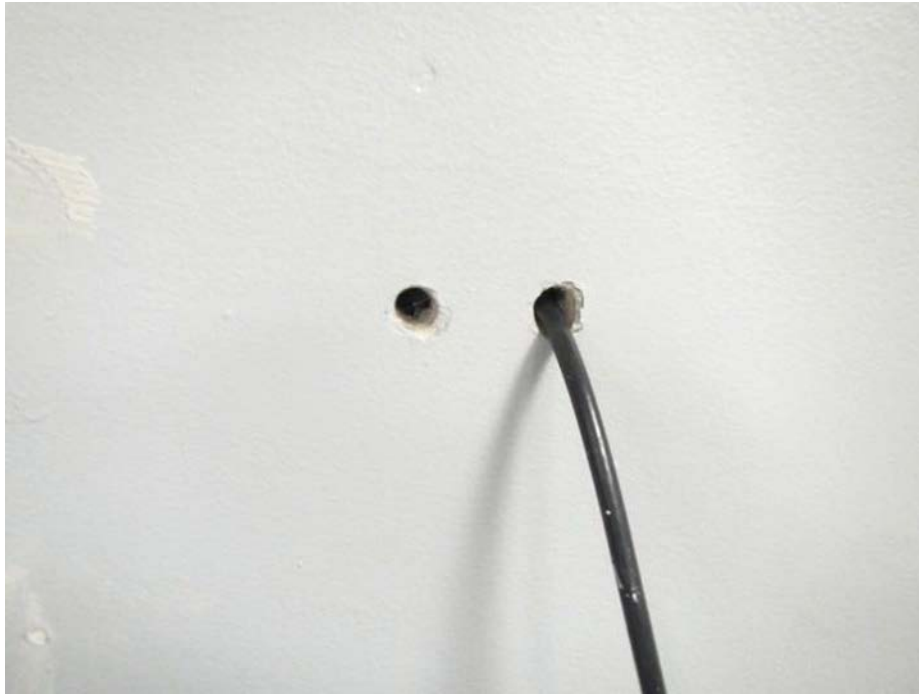
**Picture 11**

**Open utility holes in wall**

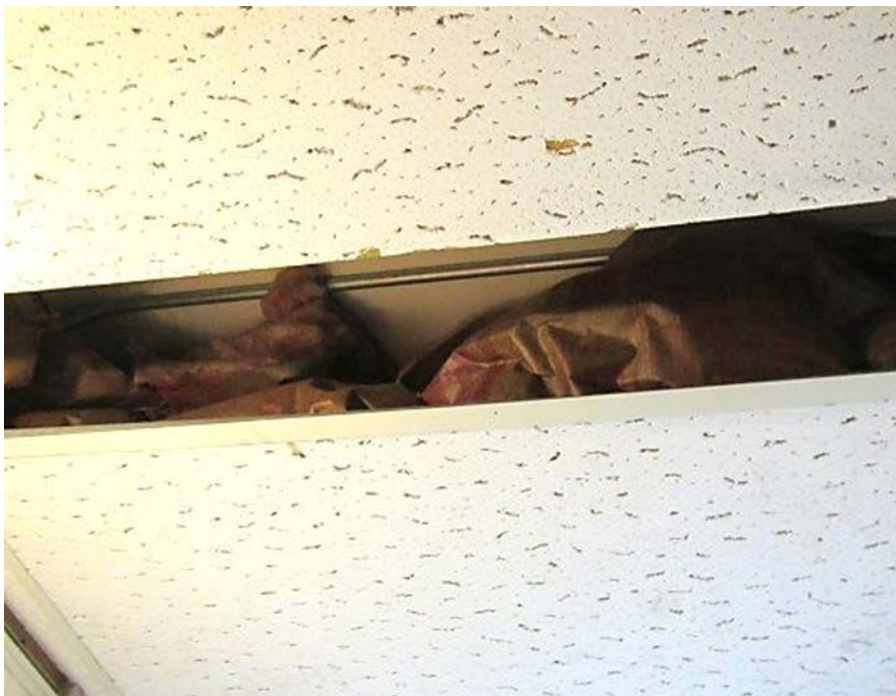
**Picture 12**

**Ajar ceiling tile exposing fiberglass insulation**

14. Replace missing/ajar/damaged ceiling tiles to prevent exposure to dust/debris/fiberglass.
15. Occupants should utilize open windows and AC units set to “fan only” mode during temperate weather to increase ventilation in occupied areas. Occupants should refrain from opening windows during AC cooling mode and remember to also close windows during driving rain storms to avoid further water damage.

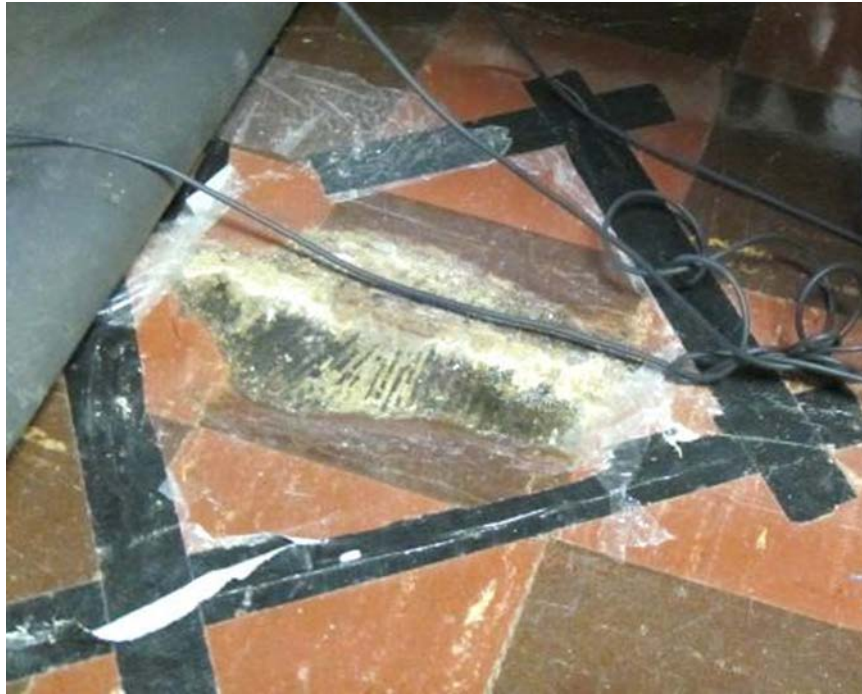
**Picture 13**

Due to the age of the building, it was reported that asbestos-containing floor tiles are located throughout. In many areas the tiles have been carpeted over, however in several areas tiles were found to be damaged (Pictures 13 and 14).

**Damaged floor tiles**

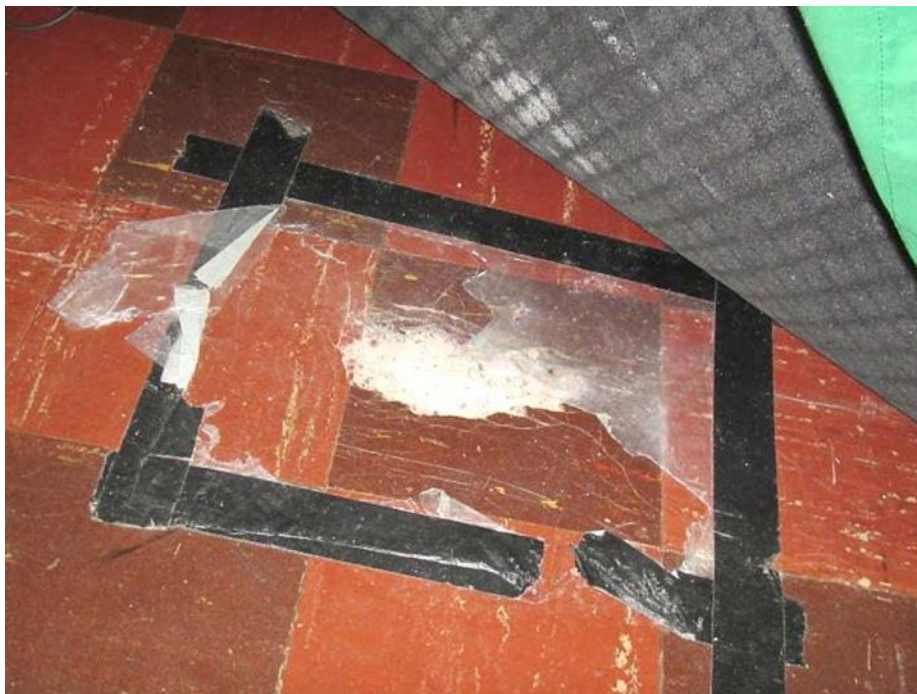
**Picture 14**

**Damaged floor tiles**

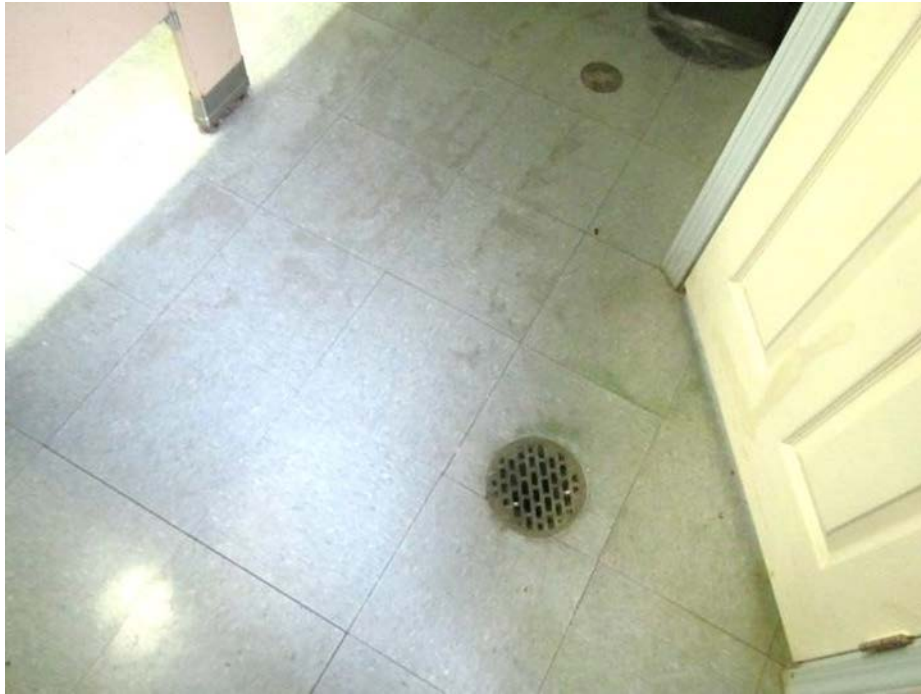
**Picture 15**

Restrooms are equipped with floor drains (Picture 15). It was reported that occasionally sewer gas odors are present. Without regular input of water, drain traps can dry out allowing sewer gases to migrate into the building, which are nuisance odors and can be a source of irritation.

**Bathroom floor drain**

19. Ensure that local exhaust vents are operating correctly (e.g., bathroom) and that exhaust is ejected outside of the building.
20. Fixtures that are to be used should have water poured into drains on a regular basis to avoid dry drain traps.

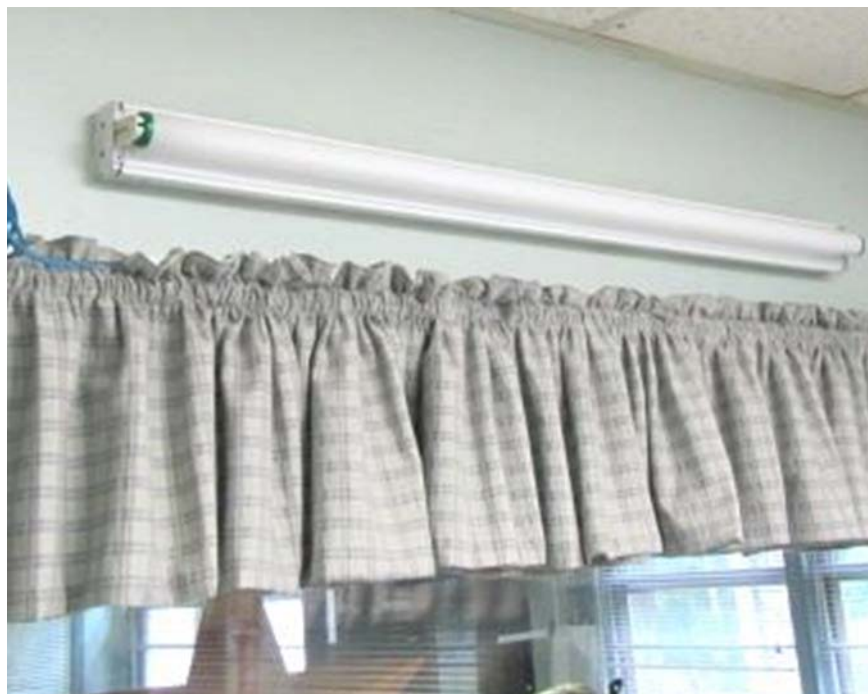
**Picture 16**

Finally, florescent light covers were missing in the Clerk's Office (Picture 16). Fixtures should be equipped with access covers installed with bulbs fully secured in their sockets. Breakage of glass can cause injuries and may release mercury and/or other hazardous compounds.

**Missing florescent light cover**
